Vibration Evaluation of Cable Penetration Sealing System for Earthquake Resistant by Dynamic Structural Testing System

ABSTRACT

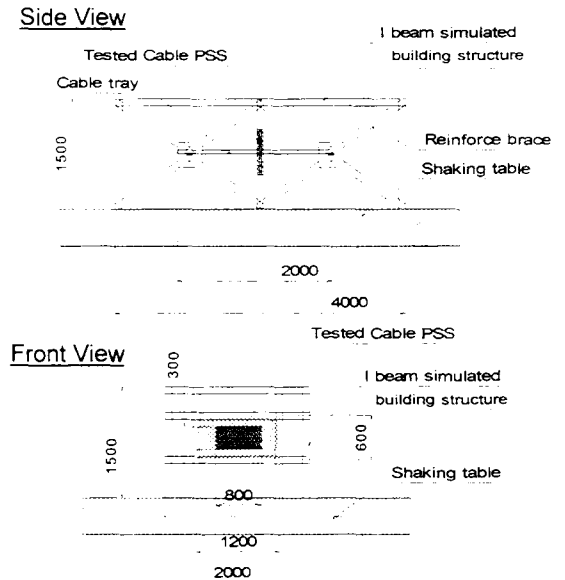
Fig. 10 Summary of the vibration test system

Fig.10 shows the summary of the vibration test system. This vibration test were simulated nature of the ground motion (both horizontal and vertical) by a building structure of wall using I beam steel frame.

Full scale vibration tests were performed using dynamic structural testing equipment which is the shaking table can achieve 3-dimensional movement of 6 degrees of freedom in KUMAGAI GUMI Co.,Ltd..

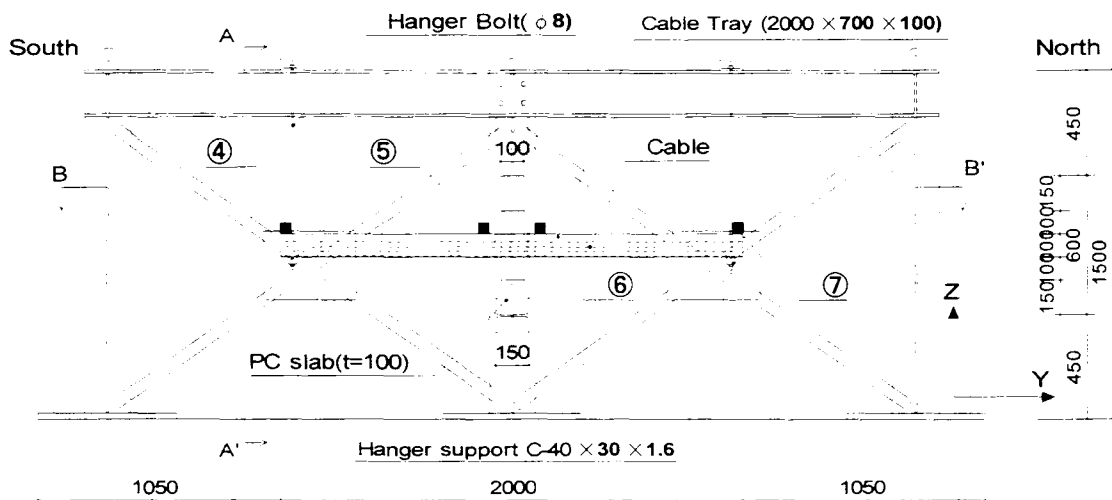
Fig. 11 C-C' cross section of settled test frame

Each test specimen was attached to a test frame. Next, each simulation concrete board was fixed in the frame with high tension bolts and a steel plate. Consequently, the concrete board will always move with the frame. A cable tray was hung from the ceiling with hanger bolts and hanger supports (typical installation method in Japan) as shown in Fig.11 to 13. The cable tray was supported so that it passes through an opening in the simulation frame. The weight of the penetrating items is supported by the frame when no load is on the cable PSS at vertical direction. The purpose of the vibration test is to measure the acceleration at several points on the cable tray and pre-cast reinforced concrete slab for each specimen. The other points were used to measure the shaking table(①) and frame(⑧,⑩).

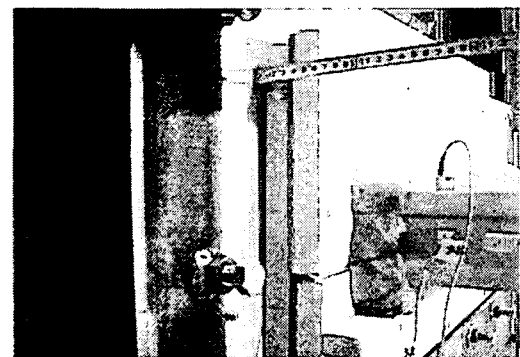
Fig.18 Condition after 1500 gal excitation

At the time of 1000 gal excitation, the board was lifted about 2 mm to the front, and at 1500 gal, as shown Fig.18, the board was further lifted about 10 mm, and the upper and lower boards became loose. An anchor bolt to fix the board can be seen. During vibration, a large amount of internal rock wool was confirmed to have splashed. At 1500 gal, ④ $F_{max} \doteq 820$ kg, ⑤ $F_{max} \doteq 885$ kg.

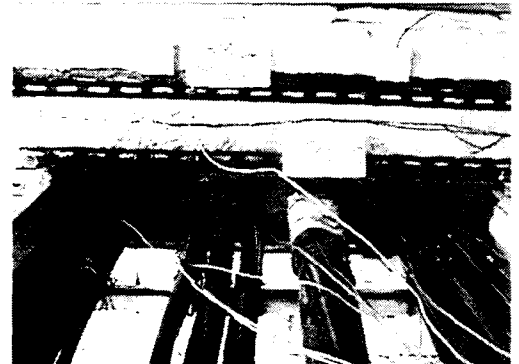
Fig.20 Condition after 120 min fired

<u>time</u>	<u>observations</u>
2	Light smoke coming from the open top of CVT cable.
60	Smoke stopped. CVT 100 cable jacket is bulging.
90	CVT 60 cable jacket is bulging.
120	No apparent change.(Fig.20) Furnace fire extinguished.

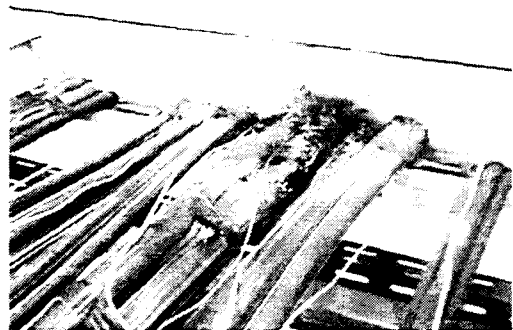
Fig.22 Condition after 120 min fired

<u>time</u>	<u>observations</u>
2	Light smoke coming from the open top of CVT cable.
30	Smoke stopped.
50	CVT 325 cable jacket are bulging.
60	CVT 100 & 60 cable jacket are bulging.
90	CVT 325 cable jacket are burst.
120	Emission of light verify in CVT 325 cable.(Fig.22) Furnace fire extinguished.
