Large Scale Fire Tests: the British Steel European Collaborative Research Programme on the BRE 8-Storey Frame

B.R. KIRBY

British Steel PLC.

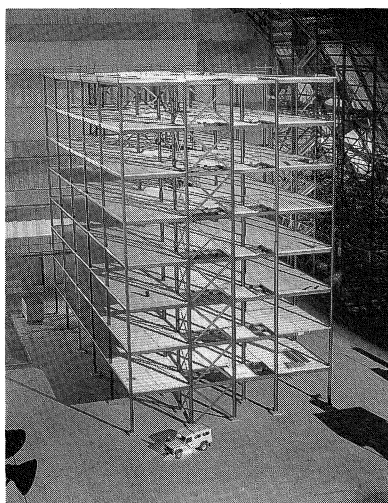
FIGURE 1. THE BRE 8-STOREY FRAME (STEELWORK ONLY) - Courtesy of BRE

The BRE frame was designed as a modern office building in accordance with the UK building codes, Figure 1. Although its purpose was for research, to ensure it was representative of modern day construction, it was built under normal commercial pressures.

The building is a modern, 8-storey composite design based upon a 6m,9m,6m grid system which in plan has an area of 945m². The main beam to column connections are simple partial depth end plates with fin plates at the secondary beam connections. Composite action is achieved by shear studs welded through the steel decking onto the upper flanges of both the primary and secondary beams. The floor slab is lightweight concrete, 130mm thick and incorporates an anti-cracking mesh. At the gable ends, blockwork walls are built full height with 0.9m high dado walls along the sides at each level.

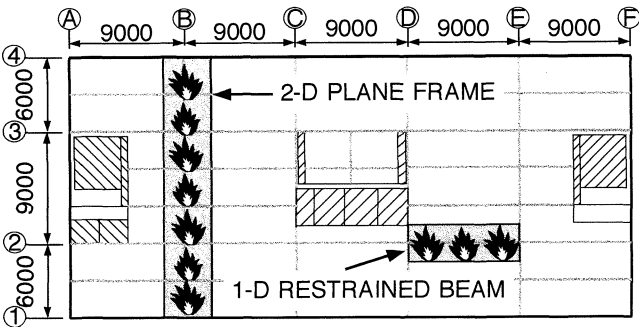
FIGURE 2. LOCATION OF TESTS 1 AND 2.

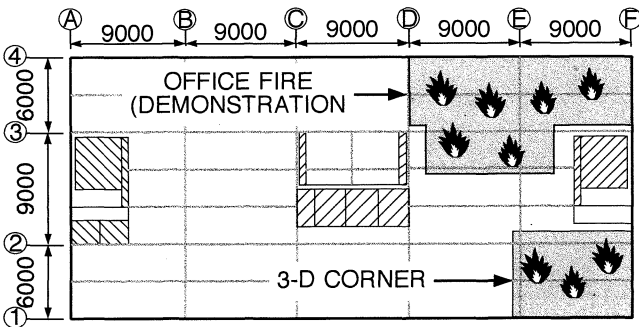
FIGURE 3. LOCATION OF TESTS 3 AND 4.

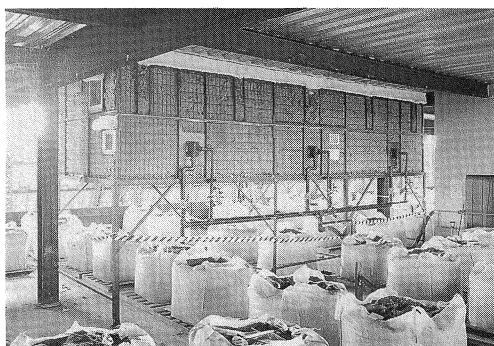
FIGURE 4. FURNACE ARRANGEMENT FOR HEATING THE RESTRAINED BEAM

The first test was carried out on the seventh floor of the building in which a furnace was designed to heat a 305 x 165mm beam and the surrounding slab spanning 9m between a pair of 254 x 254 column sections. It was also necessary to keep the connections as near as possible at ambient temperature. In view of the importance of achieving a uniform temperature profile along the length of the beam, an 8m x 3m wide gas fired furnace was built up to the underside of the floor slab, Figure 4.

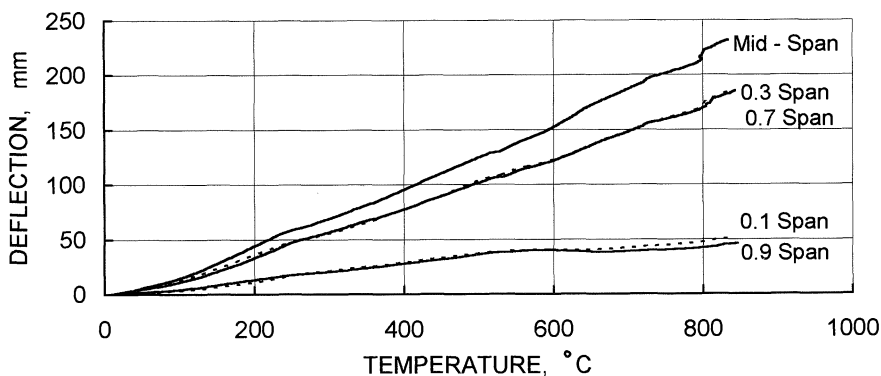
FIGURE 5. VERTICAL DEFLECTION VS LOWER FLANGE TEMPERATURE

The beam was heated between 3-10°C/min. until temperatures of 800-900°C were achieved through the section's profile. At this point the mid-span of the beam had deflected 230mm (L/35). Normally with the same level of loading applied in the Standard test, the deflection

limit ($L/30$) would have been attained at a lower flange temperature of less than 700°C . In Figure 5, vertical deflection is shown as a function of lower flange temperature at several locations along the beam which illustrates that even when the test was terminated, 'runaway' (instability) had not been achieved.

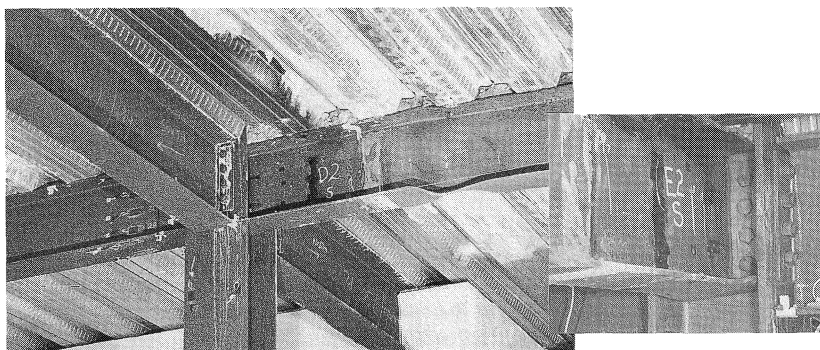
FIGURE 6. LOCAL BUCKLING AND DEFORMATION AT THE END OF THE BEAM

Figure 6 shows one end of the beam in which local buckling had occurred just inside the furnace. In addition, close examination of the ends of the beam also revealed the lower flange

had distorted, inset Figure 6, as it expanded against the web of the column section. The occurrence of these effects can be identified from abrupt changes in the strain profiles around the connections, Figure 7, as well as by other measurements such as beam rotation and lateral displacements of the lower flange.

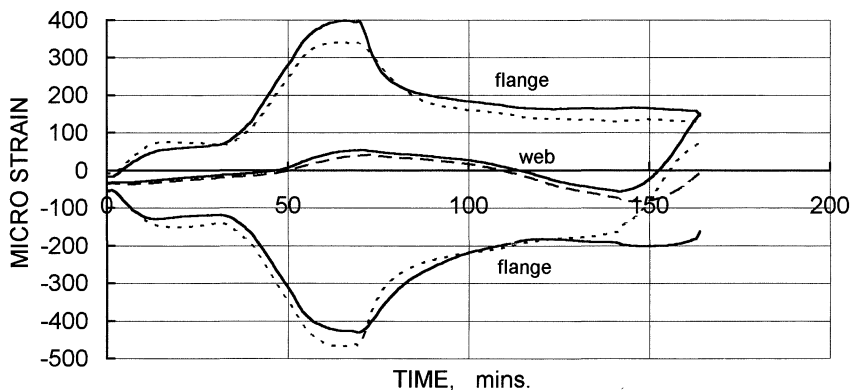
FIGURE 7. STRAIN PROFILE IN THE COLUMN ADJACENT TO THE CONNECTION

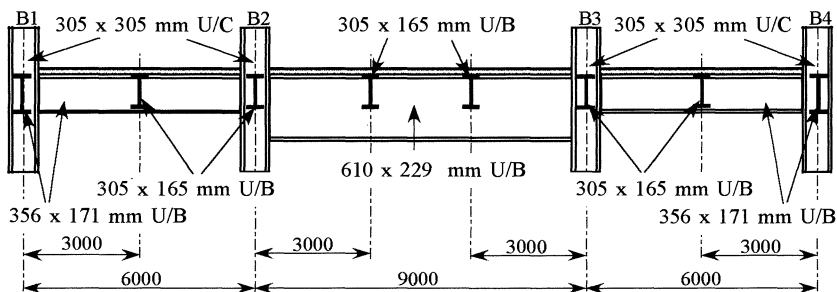
FIGURE 8. SCHEMATIC REPRESENTATION OF THE PLANE FRAME TEST

The second test was designed to evaluate the behaviour of a series of beams and columns supporting the fourth floor across the full width of the building, Figure 8.

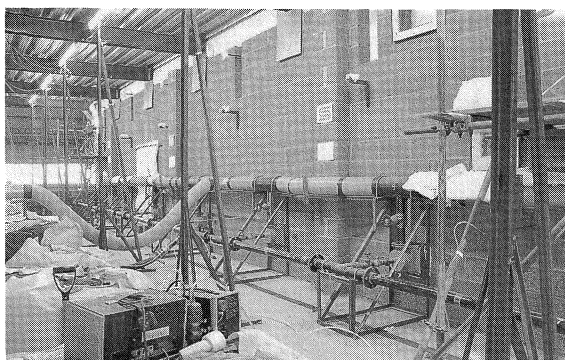
FIGURE 9. PART OF THE PLANE FRAME TEST FURNACE

Using concrete blockwork, a gas fired furnace 21m long x 4m high was built to form a corridor across the full width of the building. Slots were built into the walls to allow the secondary beams to deflect unimpeded and for instrumentation bars to transmit movement of the internal structure to externally placed transducers. Heating was provided by eight industrial burners mounted on one side of the furnace near floor level. The test arrangement was over four times longer than the Standard fire resistance furnace, Figure 9.

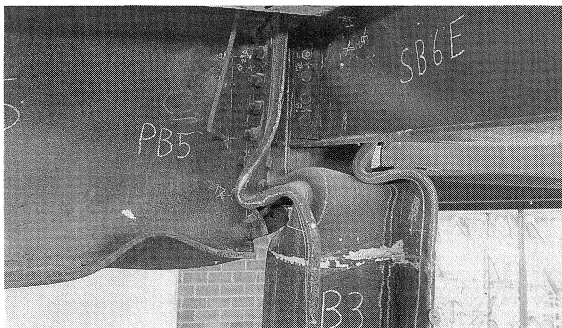
FIGURE 10. DETAIL OF AN INTERNAL BEAM TO COLUMN CONNECTION

heads and connections had grossly distorted and in effect had been squashed the 200mm clearance at the top of the fire protection, Figure 10. In contrast, the columns at either end of the frame remained relatively undistorted.

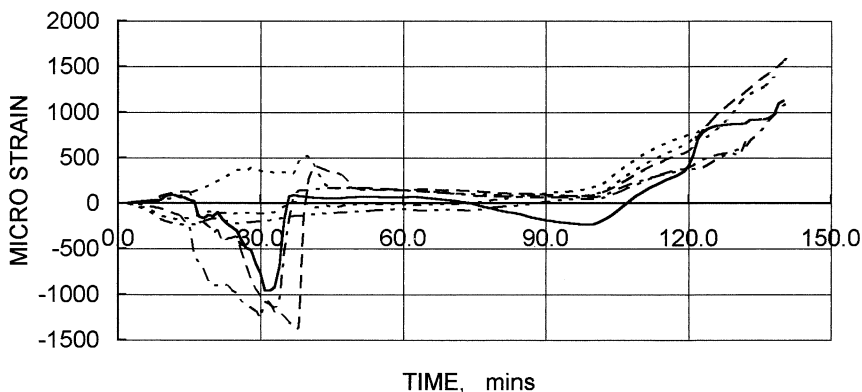
FIGURE 11. STRAIN PROFILE ACROSS AN INTERNAL COLUMN.

While the extent of deformation observed in the column was well beyond the normal acceptable limits of a Standard fire test, the structural stability of the frame was maintained by developing alternative load paths. This is illustrated in Figure 11 by the strain profile measured across an internal column within the furnace. Towards the end of the test, complete strain reversal occurred and even allowing for the induced strains existing in the structure before the test commenced, this particular member was now acting in tension.

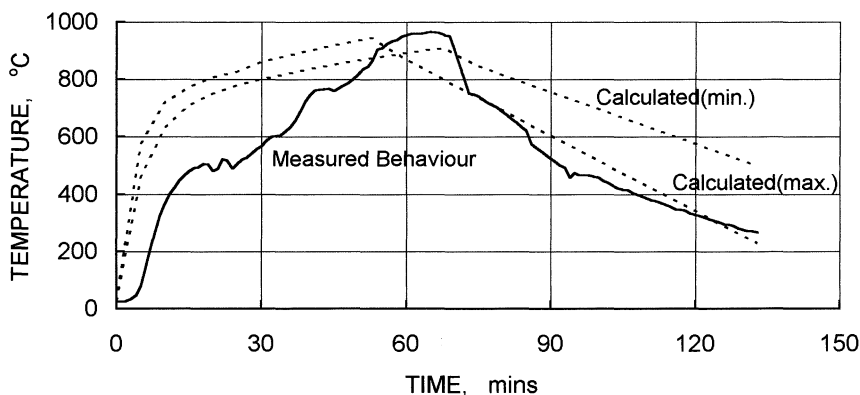
FIGURE 12. CALCULATED AND MEASURED COMPARTMENT TEMPERATURES

To test the structure, it was necessary to develop temperatures of around 1000°C. From calculations based upon the parametric equations given in Eurocode 1, this was achieved with a fire loading of 45kg of wood /m² of floor area with only a small adjustment made to the initial ventilation conditions during the test. Figure 12 compares the measured atmosphere temperatures in the compartment with the calculated parametric time temperature curves for the two ventilation conditions adopted.

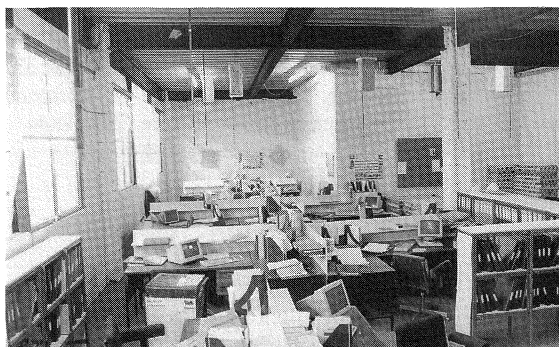
FIGURE 13. LAYOUT OF THE OFFICE FIRE COMPARTMENT

A compartment up to 18m wide and 10m deep was built on the first floor of the building to represent an open plan office. This was fitted out as a series of work stations using modern day furnishings, computers and filing systems, Figure 13.

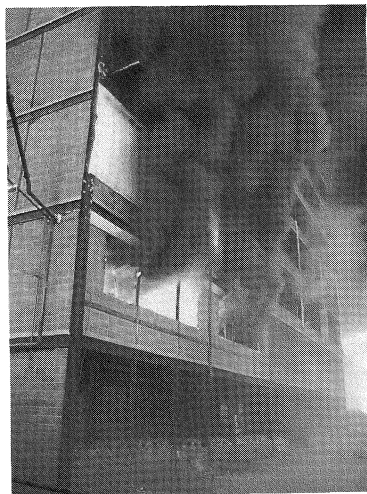
FIGURE 14. OFFICE FIRE IN PROGRESS

- * The ventilation area was also calculated to develop high temperatures in the compartment but not to be over ventilated for the fire to burn out before the structure had time to respond. Once flashover occurred the fire was ventilation controlled with a maximum heat release rate of 58MW, Figure 14.

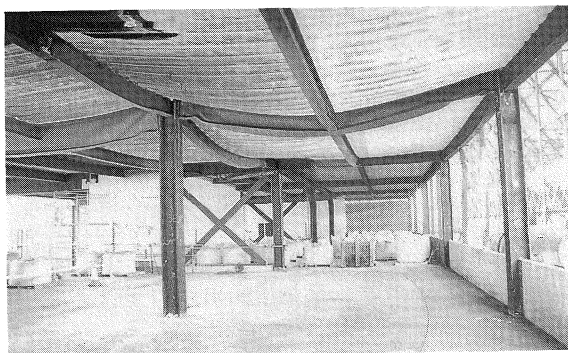
FIGURE 15. STRUCTURAL FRAME AFTER THE OFFICE FIRE

The fire was started in one corner of the compartment and within 10 minutes local atmosphere temperatures had attained 900°C. Maximum atmosphere and steel temperatures of 1150°C and 1100°C were eventually recorded. All the combustible material was completely burnt including the contents of filing cabinets. Figure 15 shows the internal structure once the floor had been cleared. Although large deflections were measured, the frame was structurally stable and still carried the loads after the fire. However as a result of this deformation the integrity of the floor slab around the internal column had suffered and it was also evident that during cooling, very high tensile stresses developed at the connections due to thermal contraction of the deflected beams.
